**DEPARTMENT OF TRANSPORTATION****DIVISION OF ENGINEERING SERVICES**

Office of Structural Materials

Quality Assurance and Source Inspection

Contract #: 04-0120F4Cty: SF/ALA Rte: 80 PM: 13.2/13.9File #: 69.28**WELDING INSPECTION REPORT****Resident Engineer:** Pursell, Gary**Address:** 333 Burma Road**City:** Oakland, CA 94607**Report No:** WIR-002880**Date Inspected:** 10-Jun-2008**Project Name:** SAS Superstructure**OSM Arrival Time:** 1900**Prime Contractor:** American Bridge/Fluor Enterprises, a JV**OSM Departure Time:** 700**Contractor:** Zhenhua Port Machinery Company, Ltd (ZPMC), Changxing Island **Location:** Shanghai China

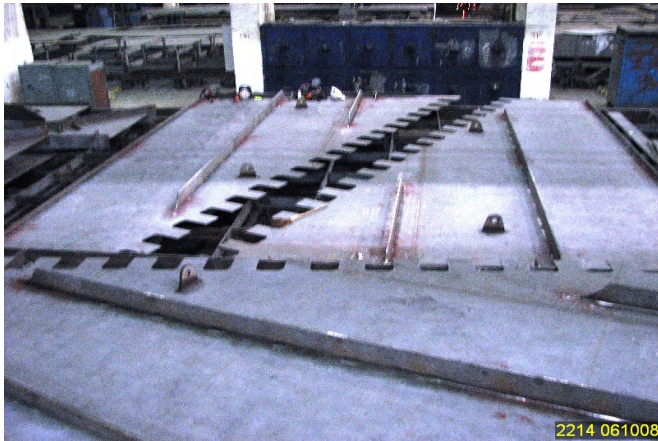
Per ZPMC MT inspection notification (00510) this Inspector performed Magnetic Particle Testing (MT) verification of the QC MT Inspected and accepted welds. QA Inspector's MT verification appears to be acceptable with AWS D1.5-02 section 6.26.2.1 & 6.26.2.3 Reference QA Magnetic Particle Test Report TL-6028 dated 6-10-08 for specific test data.

Item	Description	WBS	Dwg No.	Status
1	Above picture Various floor beam welds for MT
